NATICK POND DAM

R.I. 03801

PHASE I INSPECTION REPORT
NATIONAL DAM INSPECTION PROGRAM

JUNE 1979

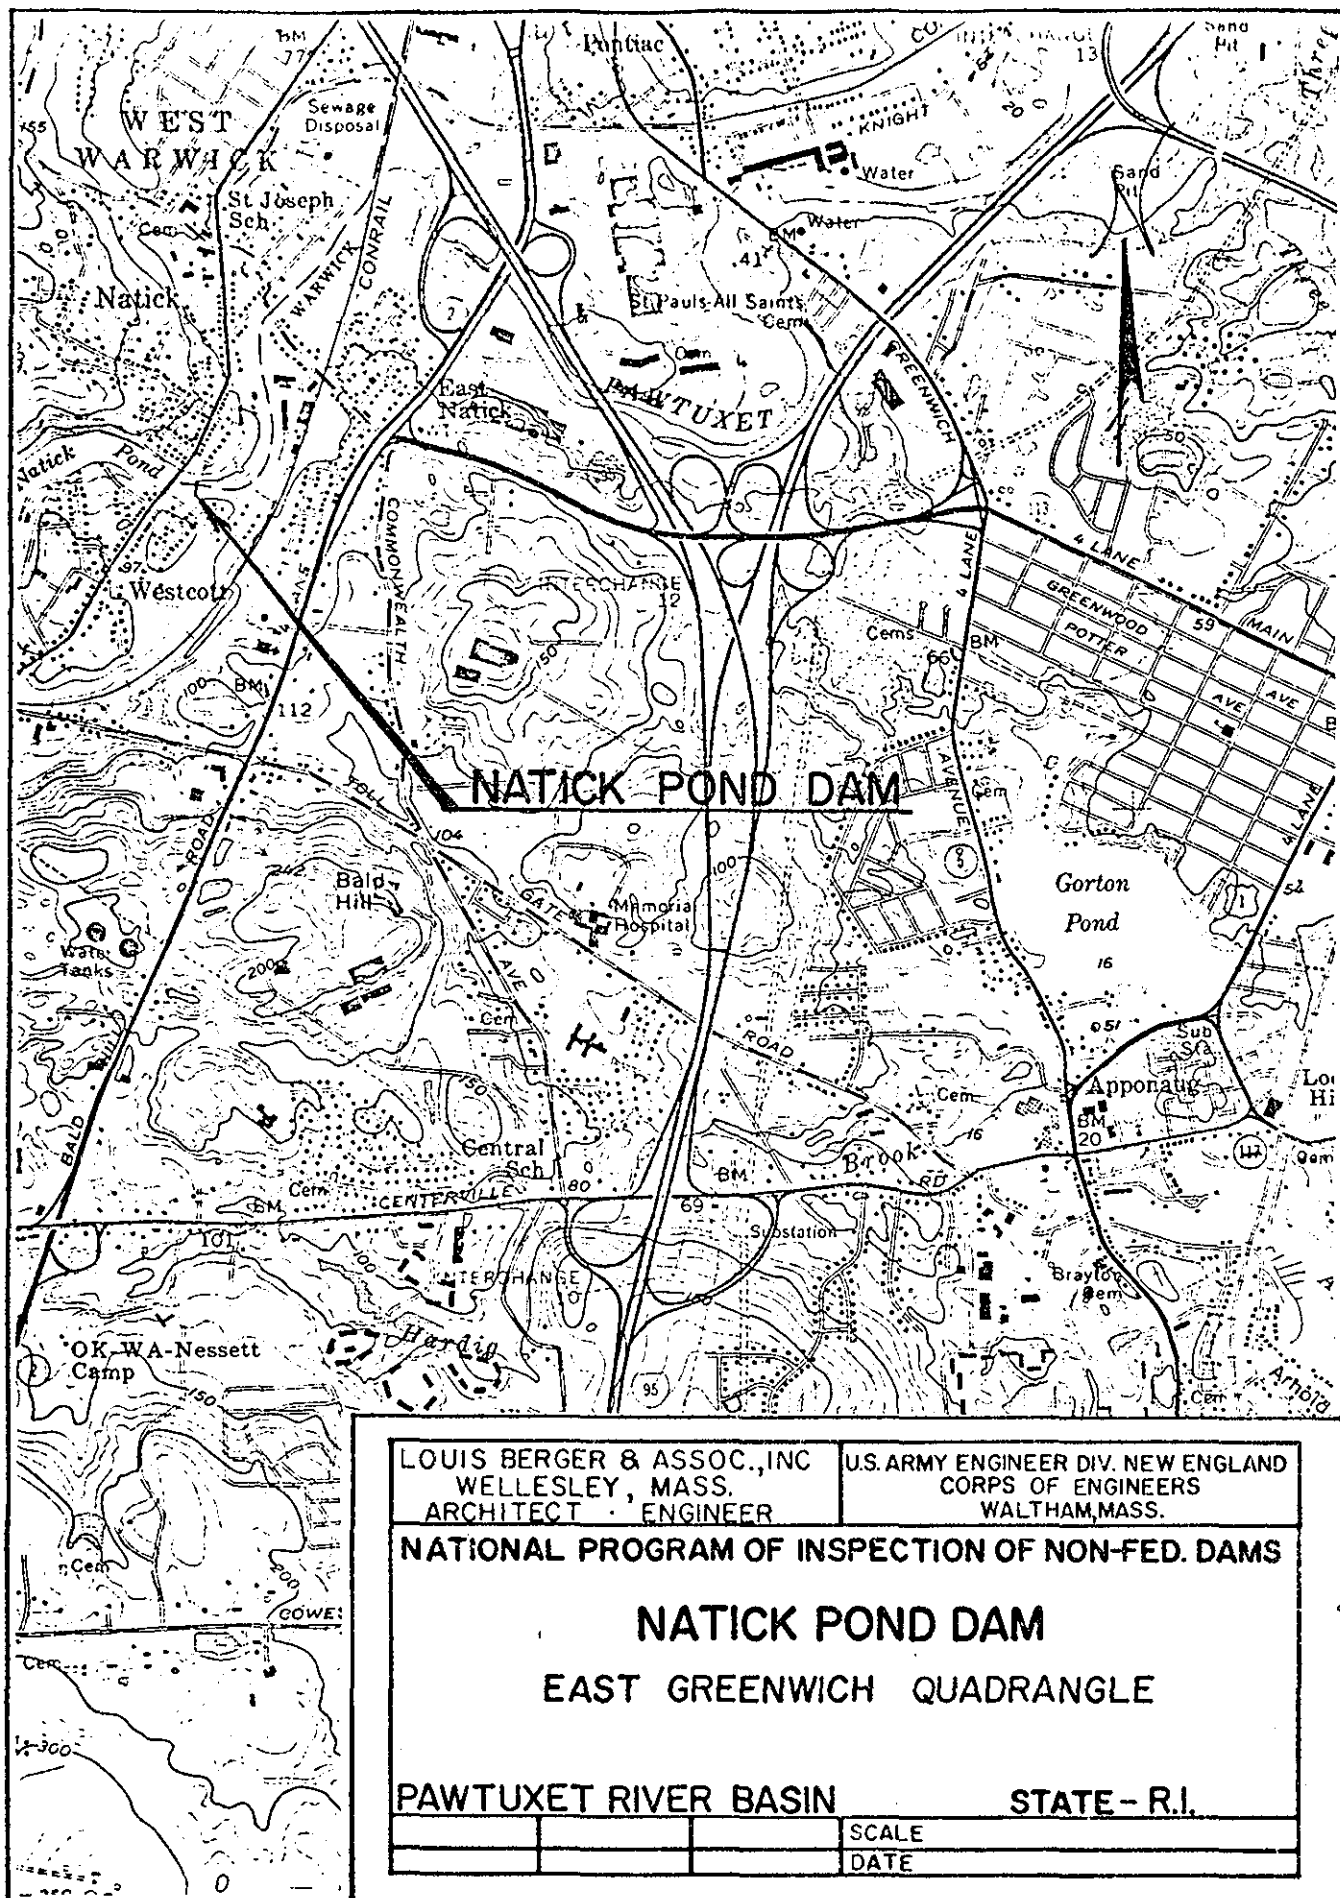
Overview Photo from right abutment

b. Dam. The dam is a run-of-the-river dam with an overall length of about 263 ft. The right granite masonry abutment is founded on bedrock, which is well exposed for a distance of about 500 ft. downstream of the dam. The left abutment contains a filled-in mill race which formerly contained six wooden trench gates; these were demolished in 1974. The mill race below the gates formerly connected to a mill downstream on the left bank of the river. There is an earth fill between the left training wall of the spillway and the right training wall of the mill race (See Photo Nos. 3 & 4, Appendix C). Several small trees are growing in this area. The earth fill is shown to be a "puddle" fill, according to an old drawing. The base of the dam is founded on bedrock. The old mill race has been filled in for a distance of approximately 300 ft. downstream of the dam. The fill appears to be of a very blocky rock type, which may have voids in it. However, at the upstream end, the fill appears to be more sandy, containing more fines. These fines extend downstream for a distance of 20 to 30 ft. No evidence of any major seepage through this area was noted. (See Overview Photo, Page V)
